Improving Water System Control Through Effective Valve Management

IRWA Annual Conference

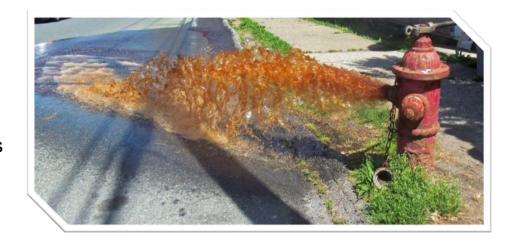
Common Problems: Incorrectly Closed Valves

Closed Valves = Dead Ends

- Aged Water
- Reduced Chlorine Residuals
- Potential for Increased Disinfectant By- Products
- Reduced Fire Fighting Capacity
- Reduced System Pressure (Low Flow)
- Increased System Pumping Costs

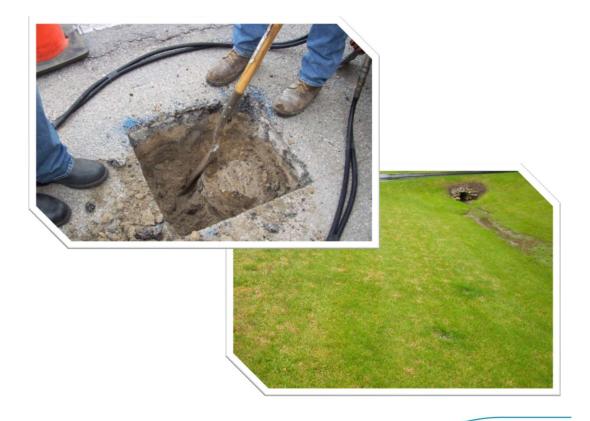
Common Problems: Buried/Paved Over Valves

- Inaccessible during emergencies, must move back and find available valve
- Longer duration, and wider footprint
- Condition of valve unknown

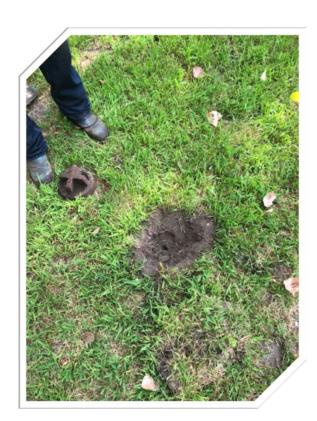
Common Problems: Debris in Valve Box

- Overtime mother nature can easily shift debris into the valve box
- In order to key the valve, must vacuum debris out
- We use a combination of vac and high-pressure water source to create a mini hydro-vac

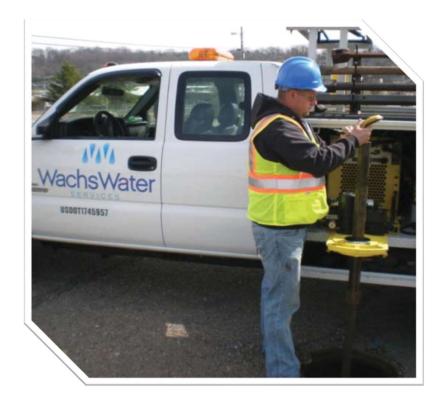
Common Problems: Seized Valves

- Valve fails to operate at recommended manufacturer torque
- Use of hydraulically operated and micro-processor-controlled equipment is recommended for this repair
- Wachs Water Services has 93%+ success rate with this repair

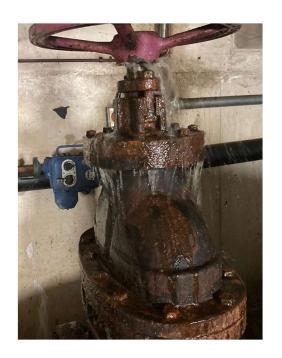
Common Problems: Packing Leaks

- A packing leak can be present or begin when valve is operated. Most of these leaks can be "snugged" up and leak will stop
- If valve is accessible in a vault or manhole these packing can be repaired or replaced under pressure
- We document these occurrences

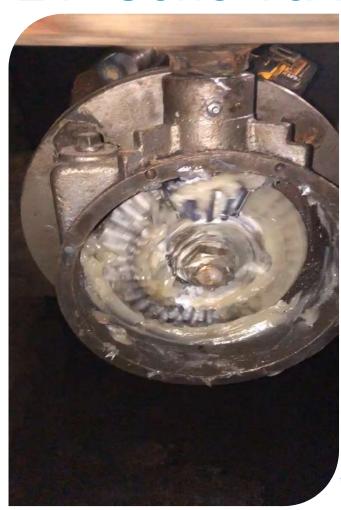
Sterling Heights, MI – 24" Cone Valve

- New bull and Pinon gear / shaft
- New stem
- New grease
- New bearings

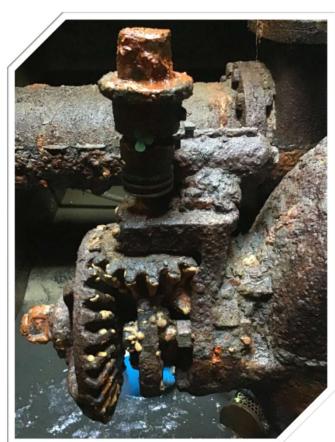
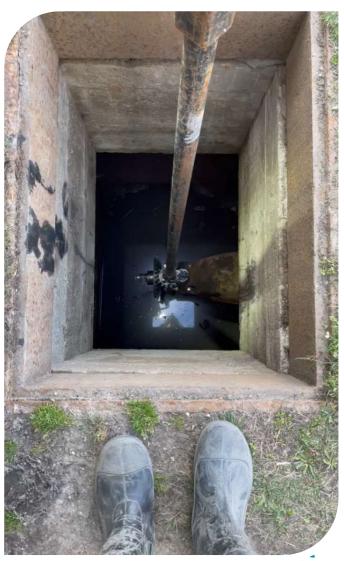
Bay City, MI - DDG

- 1921 24" Clow DDG
- City observation was a packing leak
- Valve also need new bull and pinion gears and shaft
