# CasingGaurd™ SwagingTechnology

Presented By: Mike Nailor

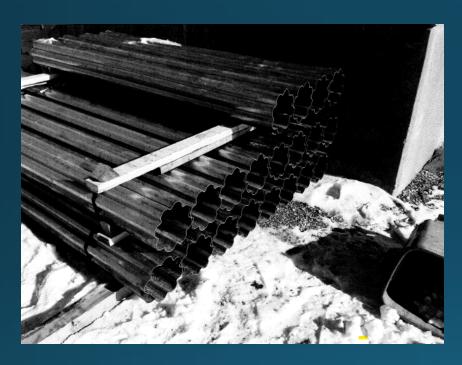
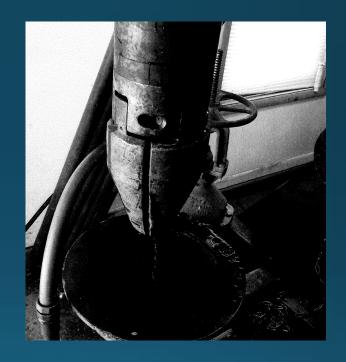
#### Old Technology

This is the old corrugated style patch utilizing 3 plates to press the stainless-steel patch out to the ID of the well casing. It does not provide for a cylindrical fit to the ID of the casing compromising the overall structural integrity of the patch.

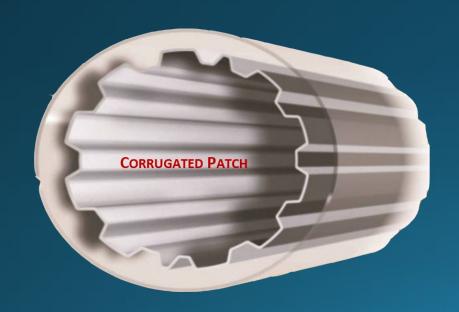
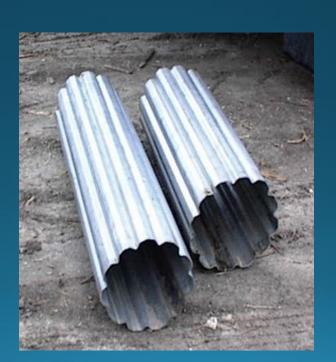
#### Not all Swage Systems are Created Equal

- Hydraulic Swage System
- Sleeve is vertically Corrugated
- Tool is repeatedly rotated in an attempt to create a cylindrical patch.

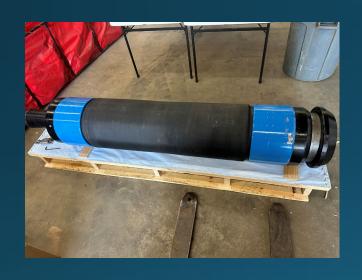
#### New CasingGuard™ Swage Technology

The New CasingGuard™ Swage
Technology utilizes a perfectly
round piece of Sch 10 Stainless Steel
Pipe and an inflatable packer
element to grab and swage the
patch into place, providing a perfect
cylindrical fit to the ID of the well
casing.

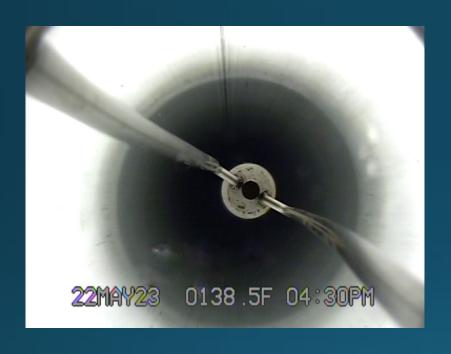
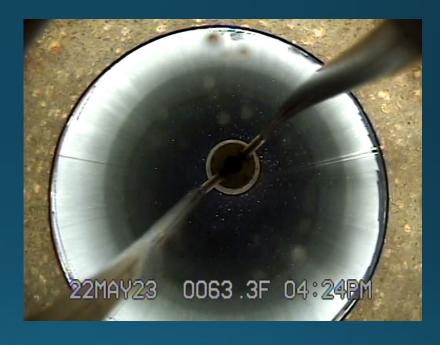
#### Final Installation

The final installation provides a perfect cylindrical fit to the ID of the casing with very minimal reduction to the diameter of the well.

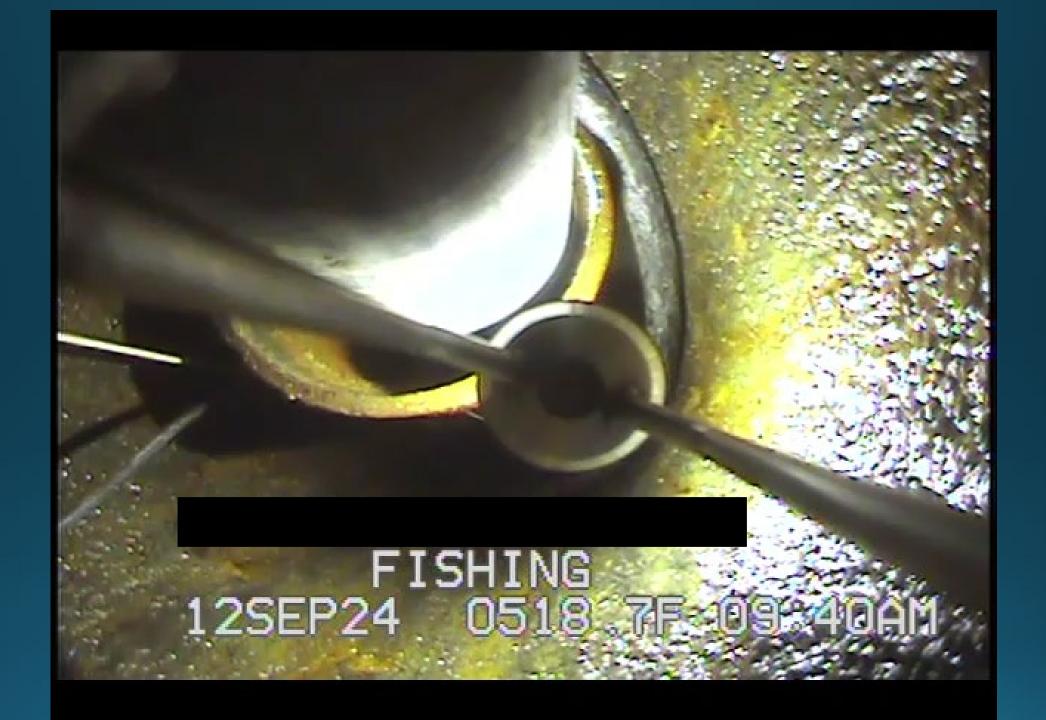
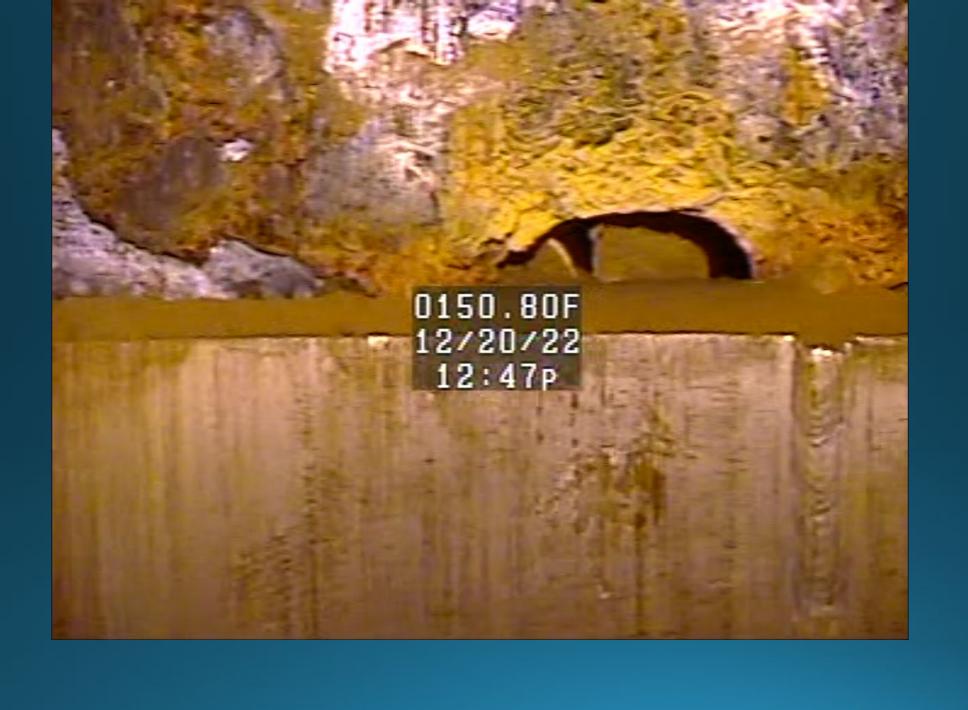
### Fishing Application

- Village of Union Grove Well #4
- 15" ID with 1,343' Total Depth.
- Contractor Drops Submersible Test Pump to the Well Bottom.
- After countless attempts, and very high cost, the contractor determines the pump removal to be impossible.
- Well was in consideration for total replacement by Village.

Salvaged well from replacement.

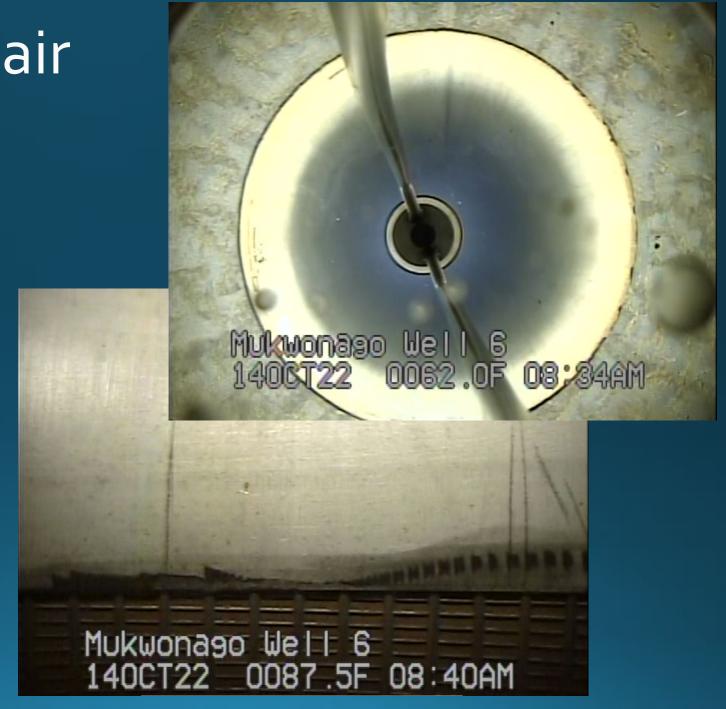
#### Results of Well Repair

Top of Liner with smooth transition.

Bottom of Liner with smooth transition.

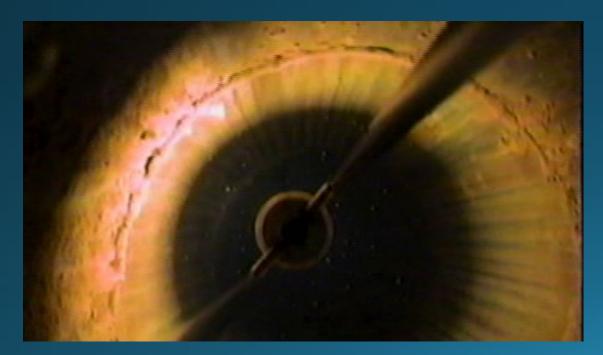
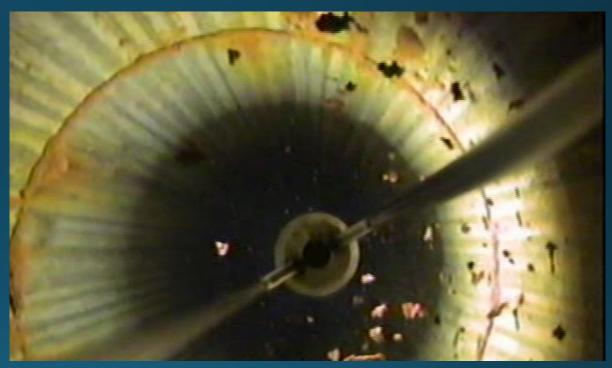
#### Not all Swage Systems are Created Equal

- Hydraulic Swage System
- Swage Tool cannot evenly press out Corrugation.
- Difficult to get a smooth transition.

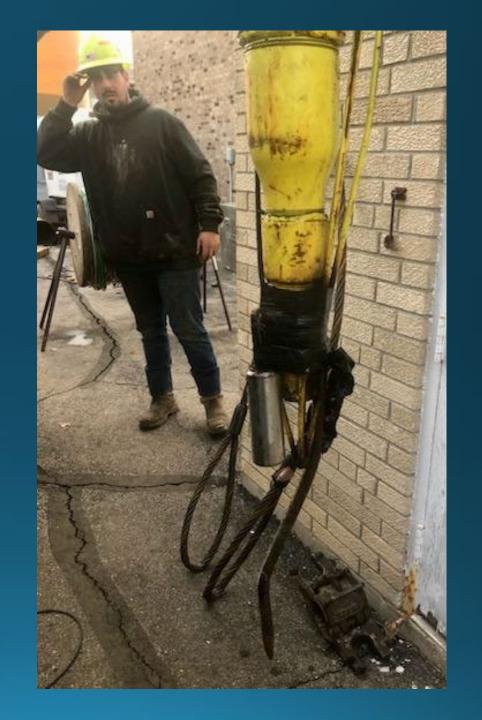
# Village of Union Grove Well #4

- 6.75" Packer with lead-in bullnose.
- Fabricated off set guide.
- Used exploratory camera to guide tool.
- Stabbed guide into pipe.
- Lowered packer into pipe.
- Inflated packer to secure in pipe.

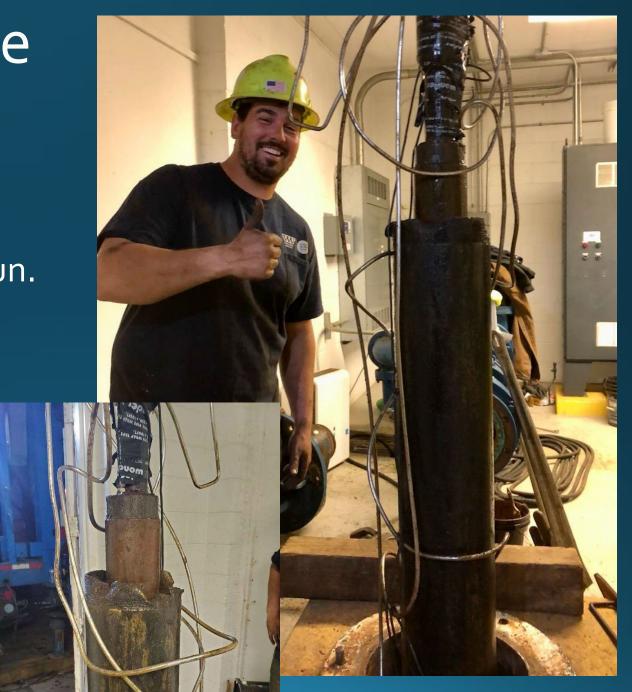
## Village of Union Grove Well #4

Recovered pipe and pump in single run.

• Entire pump assembly was removed from the well.
