Dealing with Unexpected Petroleum in Excavations Case Studies from the Village of Heyworth

SHIVEHATTERY
ARCHITECTURE+ENGINEERING

- 3 Case Studies on Petroleum in Utility Excavations
 - Buchanan Street
 - Vine Street (North)
 - Vine Street (South)
- How to Prepare and Respond when it happens to you.
- Lessons Learned

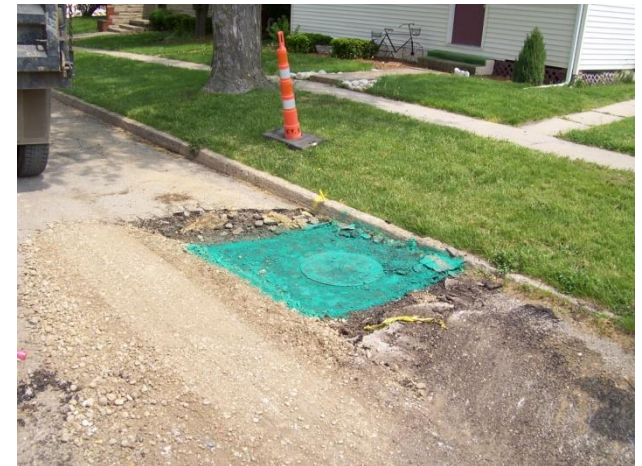
Until this manhole was found..... and opened.....

Opening the manhole revealed sludge and a strong odor of petroleum.

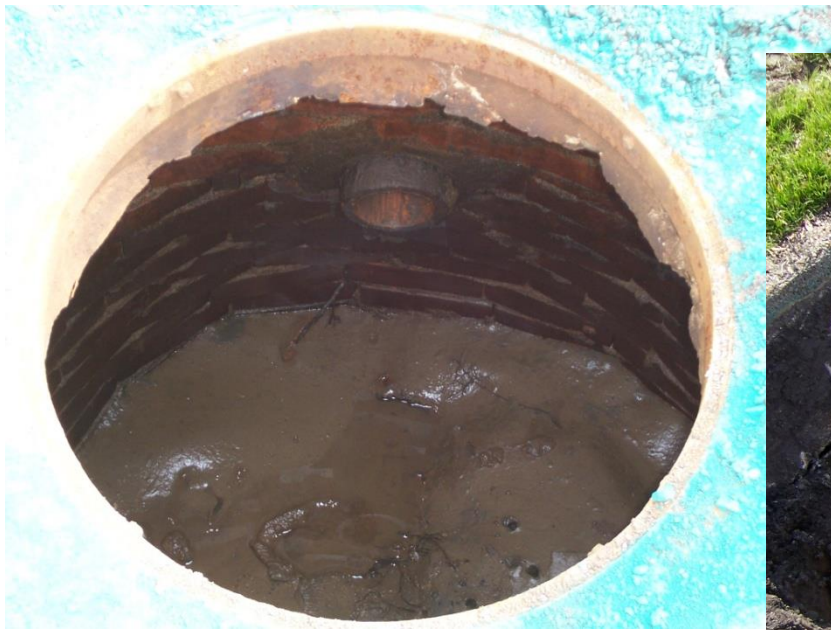
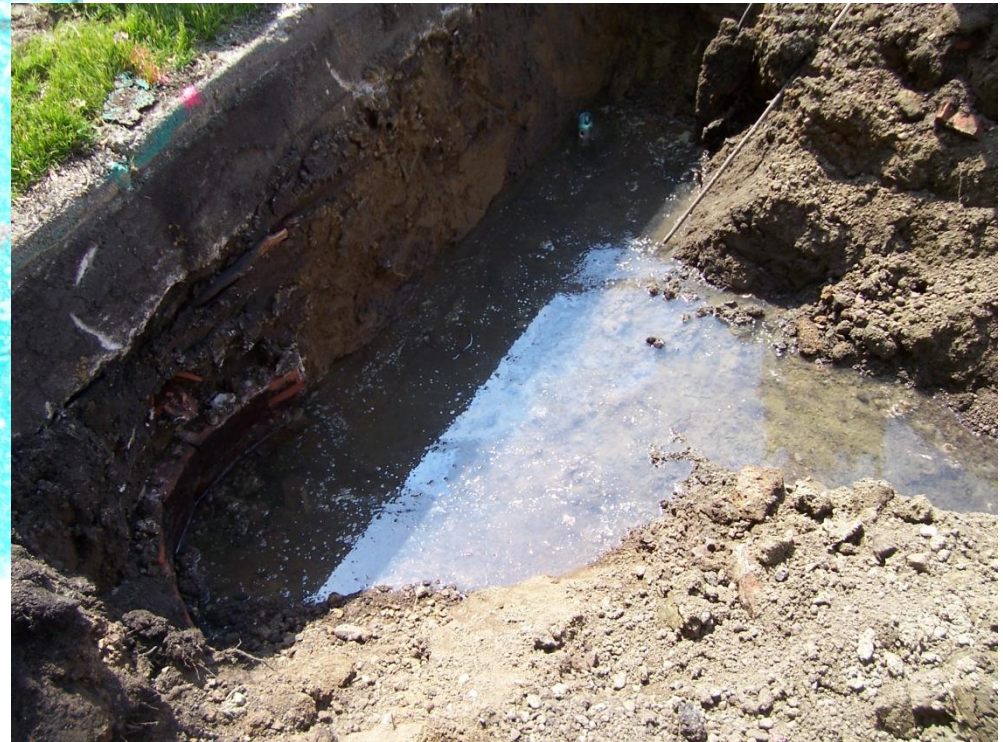
Now we have a hole, ground water, petroleum odor, oil slicks, and a PVC water main nearby.

- Need to replace PVC Water main with Ductile Iron Pipe and Petroleum Resistant Gaskets – why?
- Title 35 – Subpart F - 653.119 - f) Water mains and water service lines shall be protected against entrance of hydrocarbons through diffusion through any material used in construction of the line.
 - Permit from IEPA
 - \$\$\$\$\$ (Special Gaskets cost almost as much as a stick of pipe.)
 - Village self-constructed this portion - roughly 300' of 10 year old water main replaced – raises the question – why wasn't this found when the water main was installed.

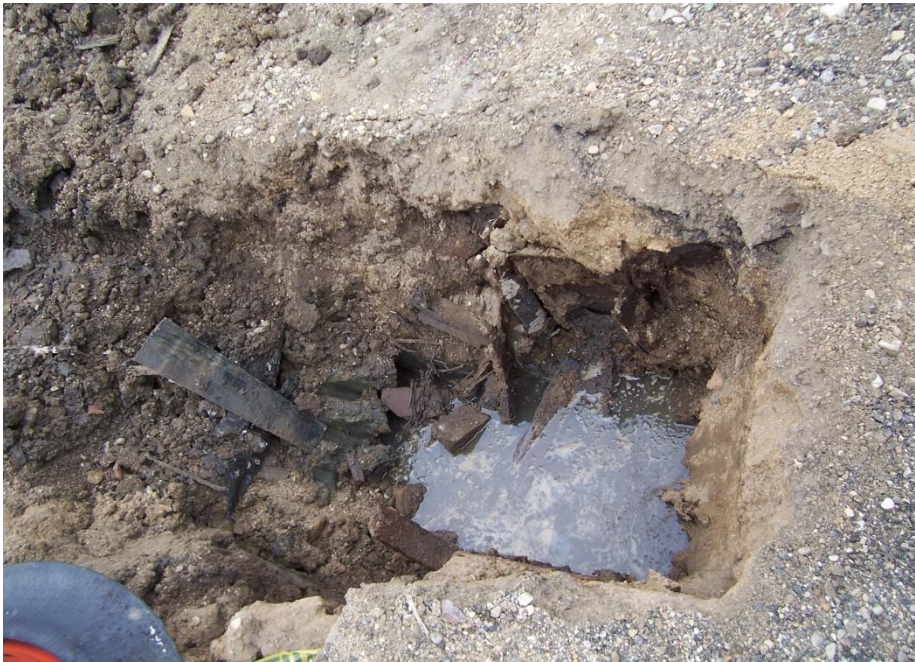
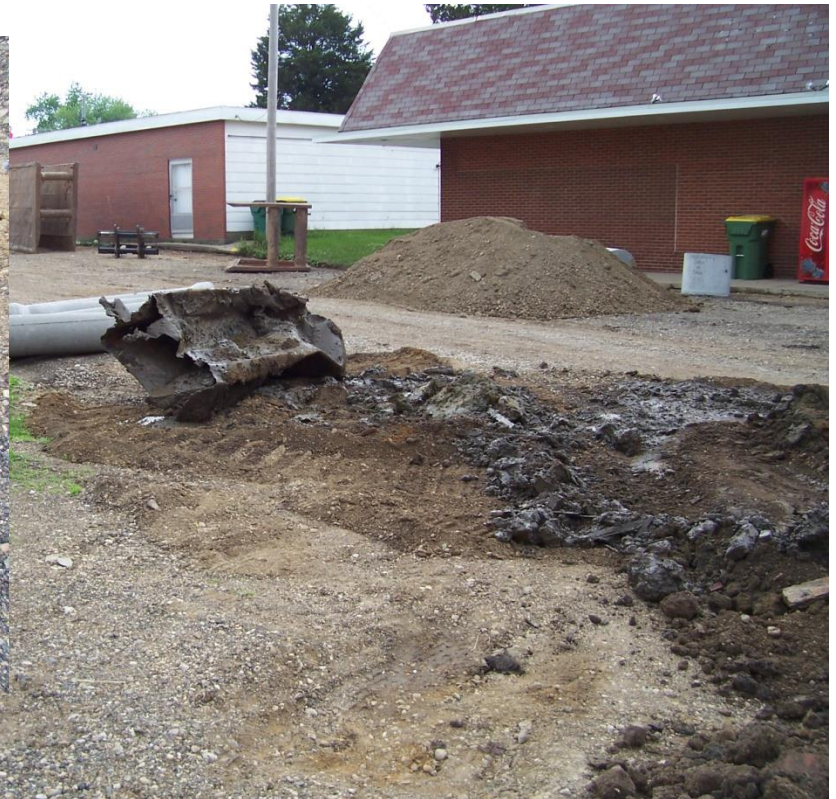
- Before the project started databases were reviewed – No documented tanks for 2 blocks
- No suspect land uses
- Hey look – A tank!!!!

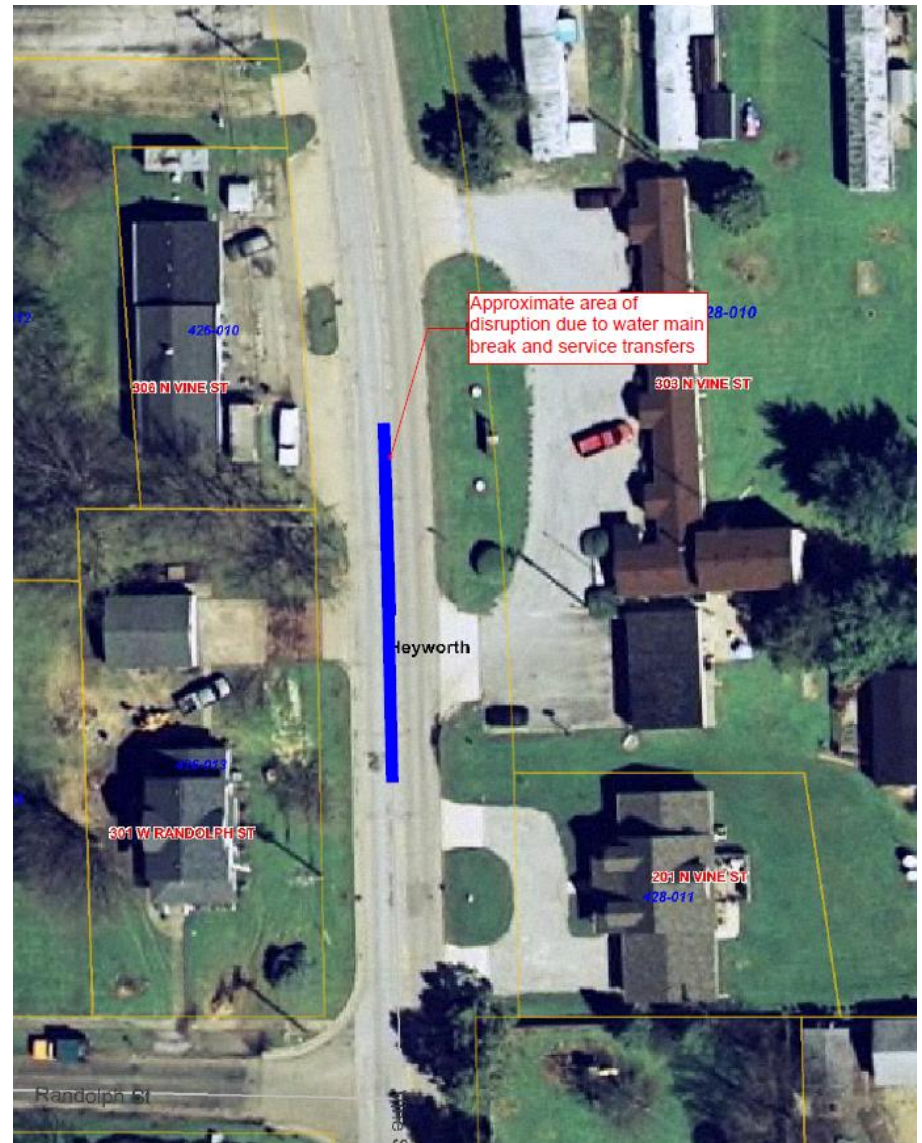
Test results

- Levels were safe for residential re-use
 - Odor strength is not a good indicator
- Public perception problems
- Liabilities????
 - Site was previously given a 4(y) closure letter
 - IDOT jurisdiction
 - Ongoing concerns IDOT storm sewer has petroleum Odor after rain events

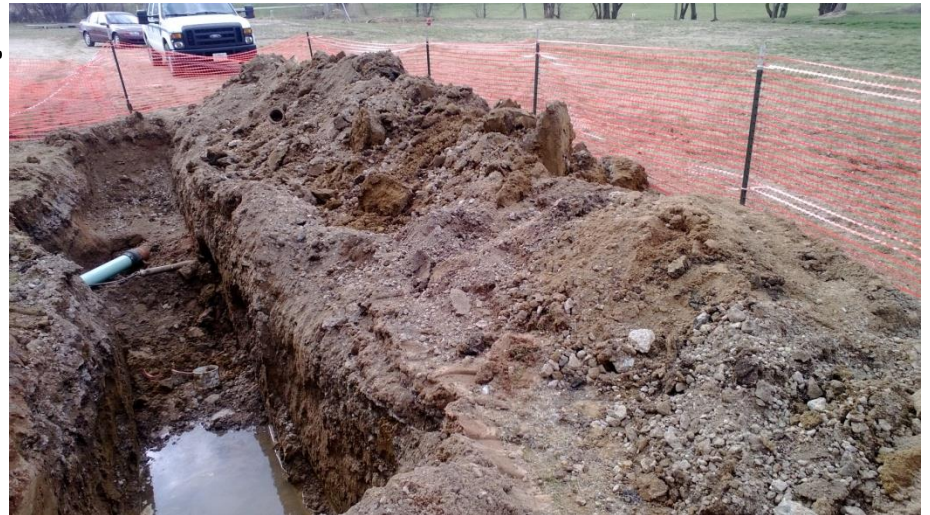
- Trying to correct a problem of a water main not in an easement.
- Need to abandon the water main and relocate a service into an easement to allow for business expansion.
- Location of water service was also the location of AST's
- Guess what we found.....

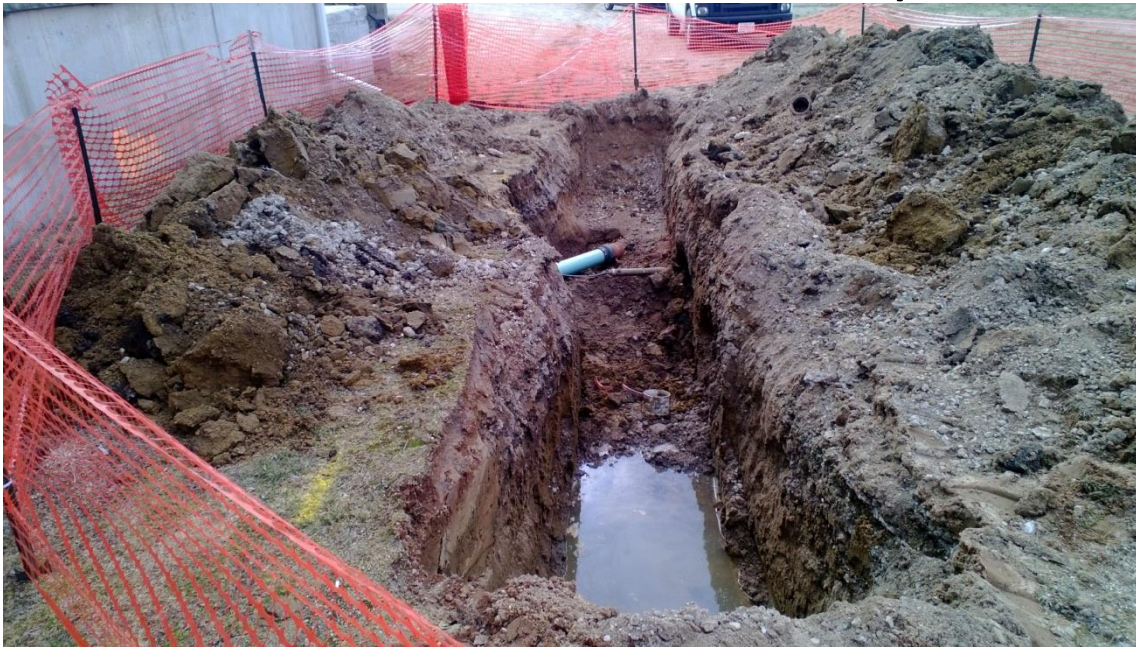
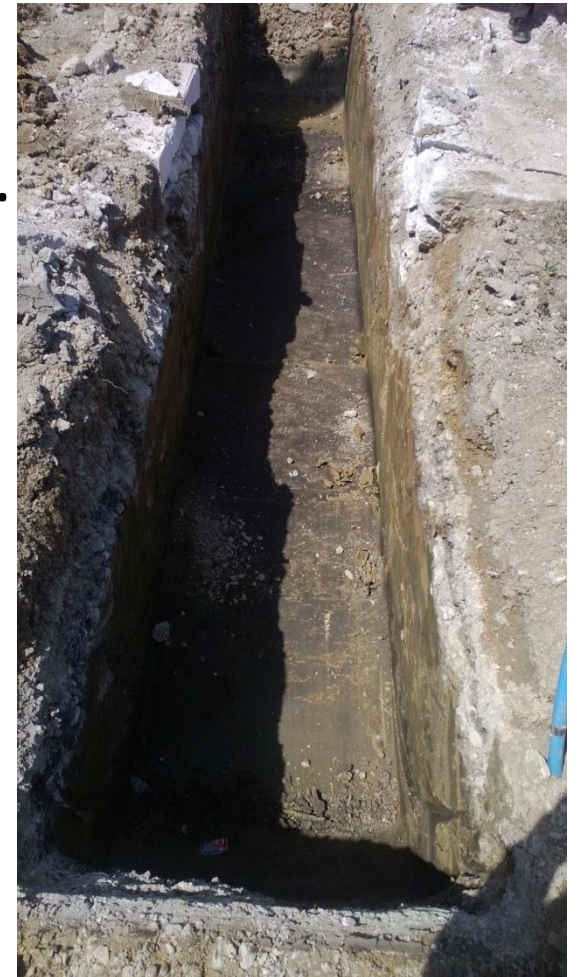
- Tests Run on Materials found
- Change in Water Service Materials
- Material Placed back in the hole, owner was notified of the problem.
